Manhole Inspection Summary

Manhole # S33E__008MH

Insp Date: **8/4/08 12:18 PM**

Location Address: **102 n liberty st**

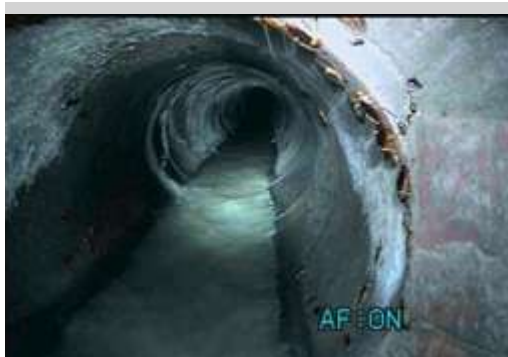
misc

inside picture of running water from seal on left side of 7

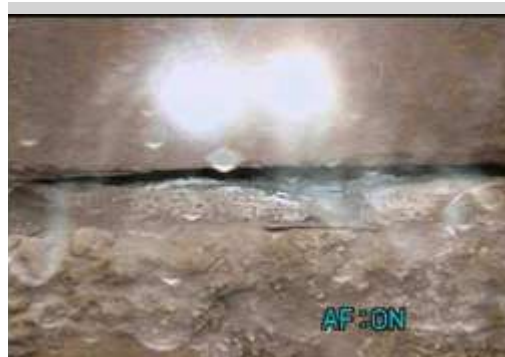
Defect 2

Condition: ☐ Sound ☐ Cracked ☐ Root Intrusion ☐ Loose Brick ☒ **Deteriorated**

deteriorated, frame adj, Gap

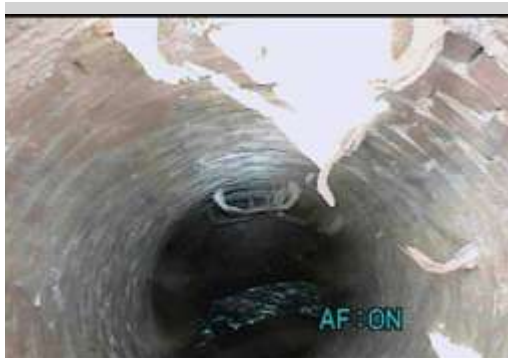
Defect 1

Steps Count: **10** Missing: **7** ☒ **Corroded**

steps

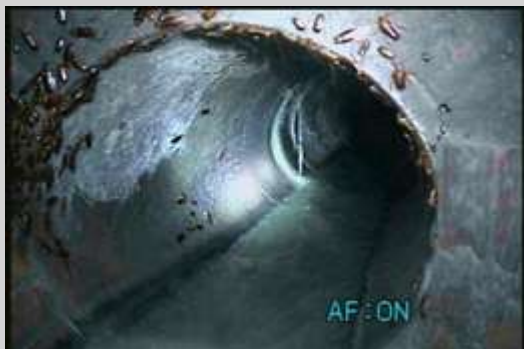
7 O'Clock Inflow

18 in. Circular Gravity Sewer
Pipe In @ 7 O'Clock

Infiltration: **Runner** Pipe Seal Cond: **Cracked**
